## MAXIMUS™ OVERFILL DIAGNOSTIC SYSTEM FOR LP GAS TANKS

Jared Meyer<sup>1</sup>

<sup>1</sup>*Adept Science & Technologies LLC, 51 Rover Blvd. Los Alamos, NM 87544, USA*

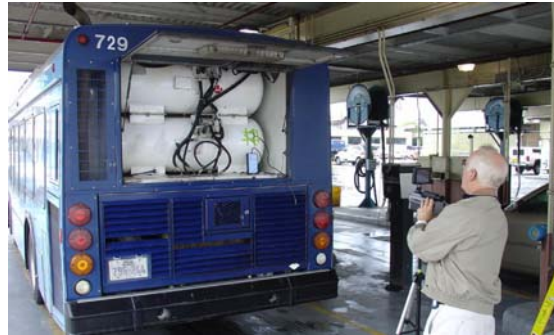
Fig. 3. Setting up Infrared Camera at VIA

The Maximus™ dual channel system tests were successful. VIA's bus #729 was set aside for extensive testing. All modes of instrument operation were tested by moving the two transducers subassemblies above and below the liquid level. The Maximus™ instrument functionality was verified by infrared camera photos showing that the ASCENT transducers were straddling the liquid level (Fig. 3 and 4). To create a temperature differential for the infrared camera to work, a small amount of LP Gas was vented to cool the liquid portion of the tank.

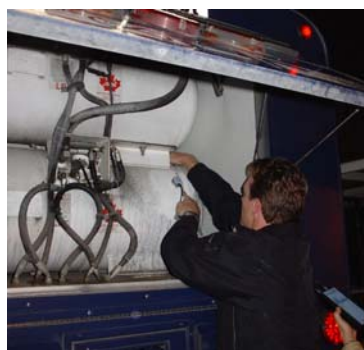
Fig. 5. Measuring the Maximus™ Detected Liquid Level after Refueling

Subsequently, data was collected from six buses during VIA's nightly fast-fill operation (Table 1). The tanks were tested with the Maximus™ instrument when the OPD stopped the flow during refueling. The arc length was measured (using a tailor's measuring tape) from the top weld of the tank to the point on the side of the tank where the Maximus™ instrument detected the LP Gas liquid level (Fig. 5). A single channel Maximus™ unit was used to non-invasively detect the liquid level by moving the magnetized sensor head assembly up and down the surface of the tank shell along the vertical axis.

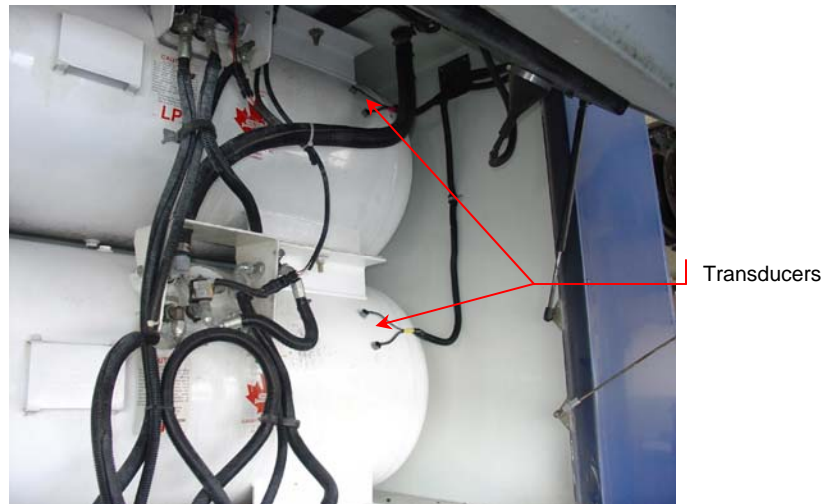
In August 2006, ASCENT engineers permanently attached sonic sensors to the outside of the tanks at 70% and 85% full (straddling above and below the 80% fill level) on 20 buses. To install the transducers on 20 buses, ASCENT manufactured 120 sensors with wires (20 buses x 3 tanks/bus x 1 wire pair/tank = 60 wire pairs). The sensors were paired up and the wires were pre-cut at lengths prescribed by VIA's maintenance foreman. The wires were routed to a junction box on the side of the

Fig. 7. Permanently Installed Transducer on Two Rear LP Gas Bus Tanks

bus. The color-coded wires were stripped and soldered to a 24-pin connector that plugs into the circuit board in the junction box. The junction box consists of a connector receptacle (where the quick-release connector on the Maximus™ instrument plugs in) and a 3-position switch. The switch allows the refueling technician to switch between tanks.
